GREAT LAKES REGION INVENTORY REPORT

NATIONAL SHORELINE STUDY

U.S. DEPARTMENT OF THE ARMY.
CORPS OF ENGINEERS.
NORTH CENTRAL DIVISION.

AUGUST 1971

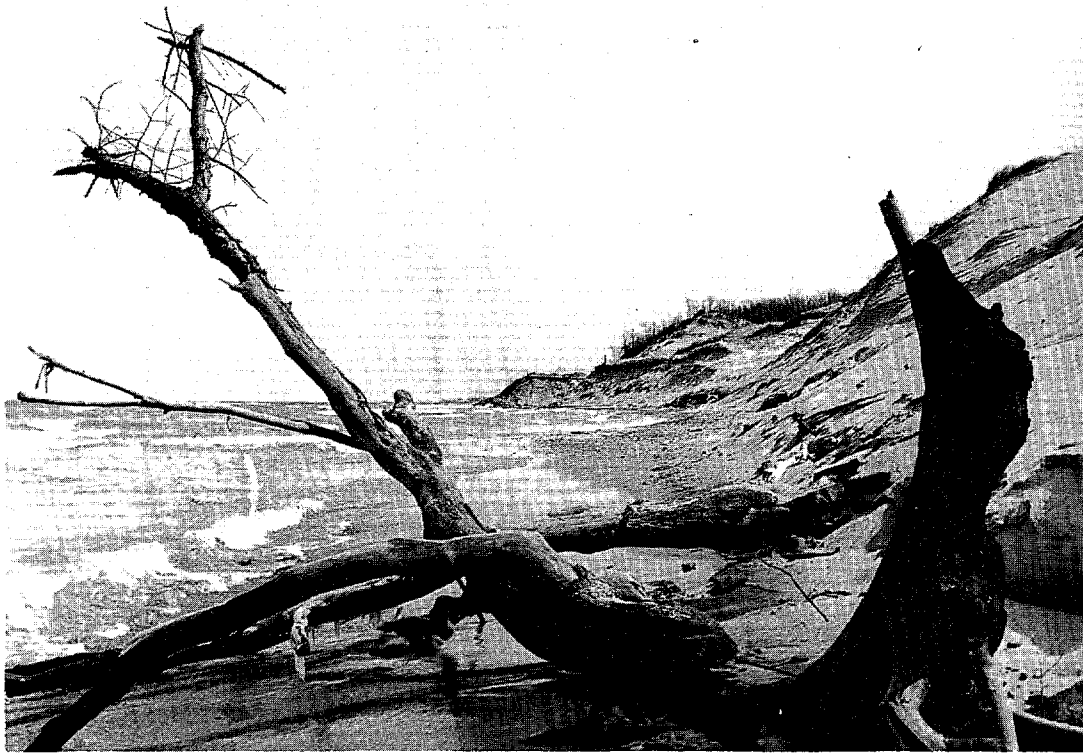
Photograph 1. The centuries-old sand dunes of the Indiana Dunes National Lakeshore are being eroded by the forces of Lake Michigan. In some cases there is almost no beach left and the waves are undercutting the 100-foot-high sand dunes.

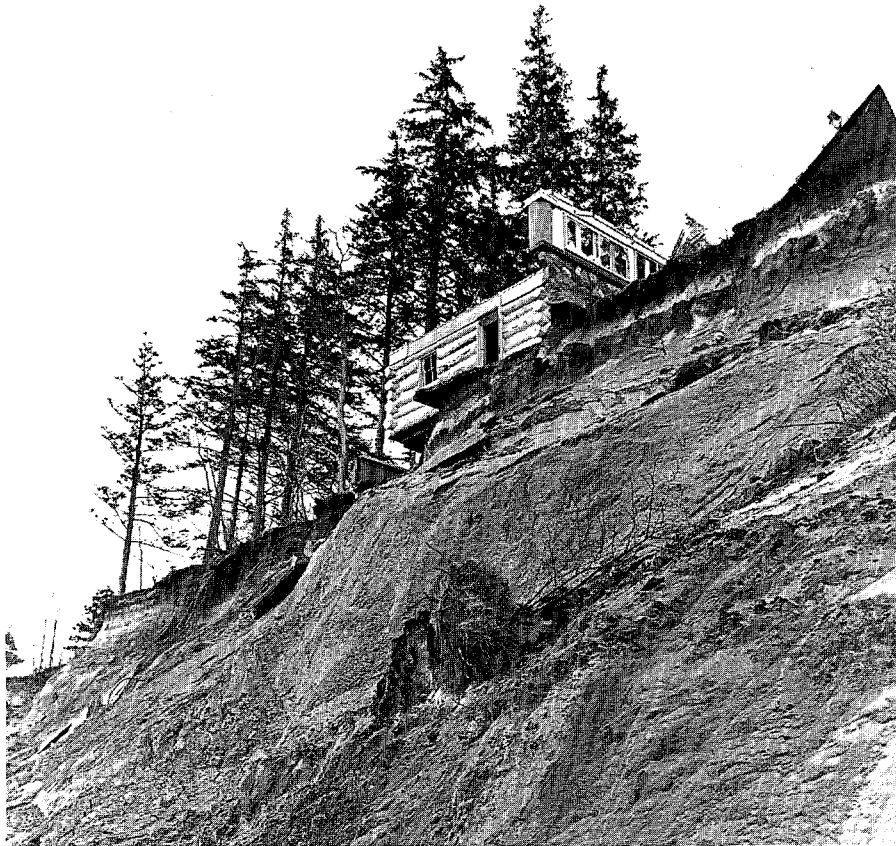
Photograph 3. Critical erosion of the Lake Michigan Shoreline in Berrien County, Michigan.

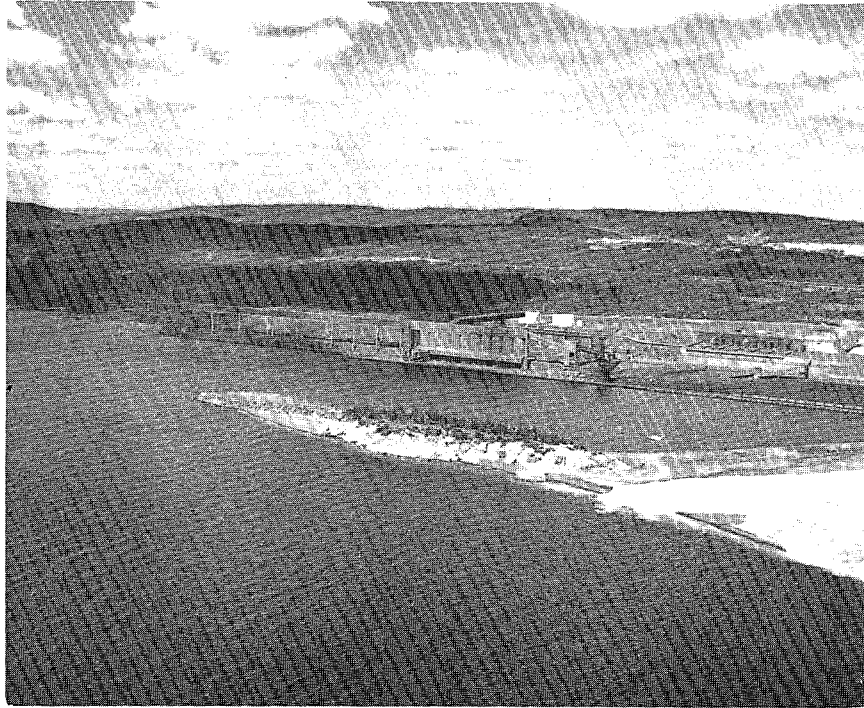
Photograph 4. Silver Bay Harbor, Minnesota - a private commercial harbor on Lake Superior.

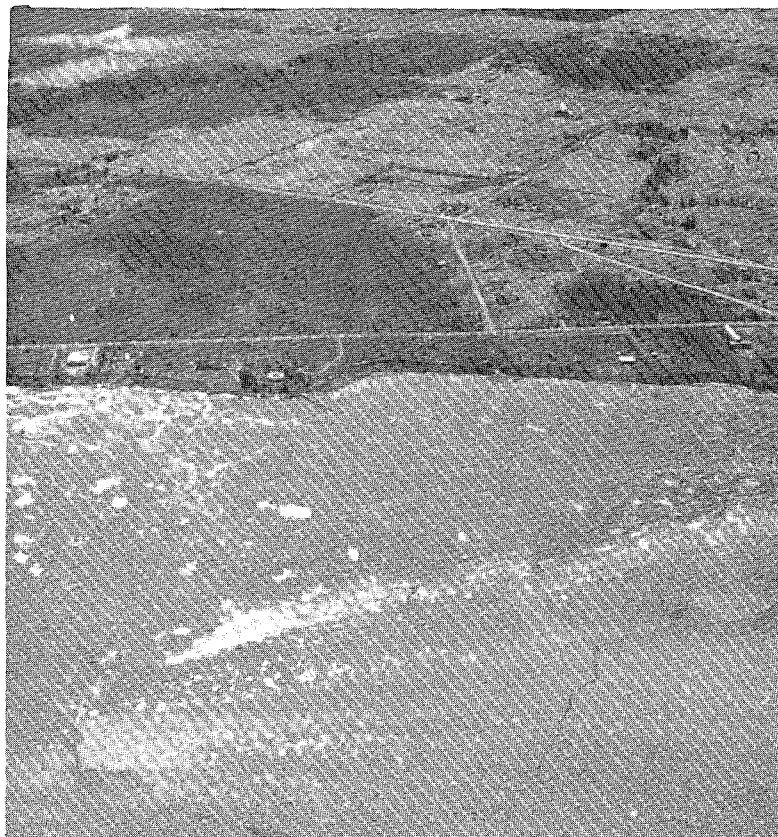
Photograph 6. Erosion along Ashland County shoreline east of Ashland, Wisconsin.

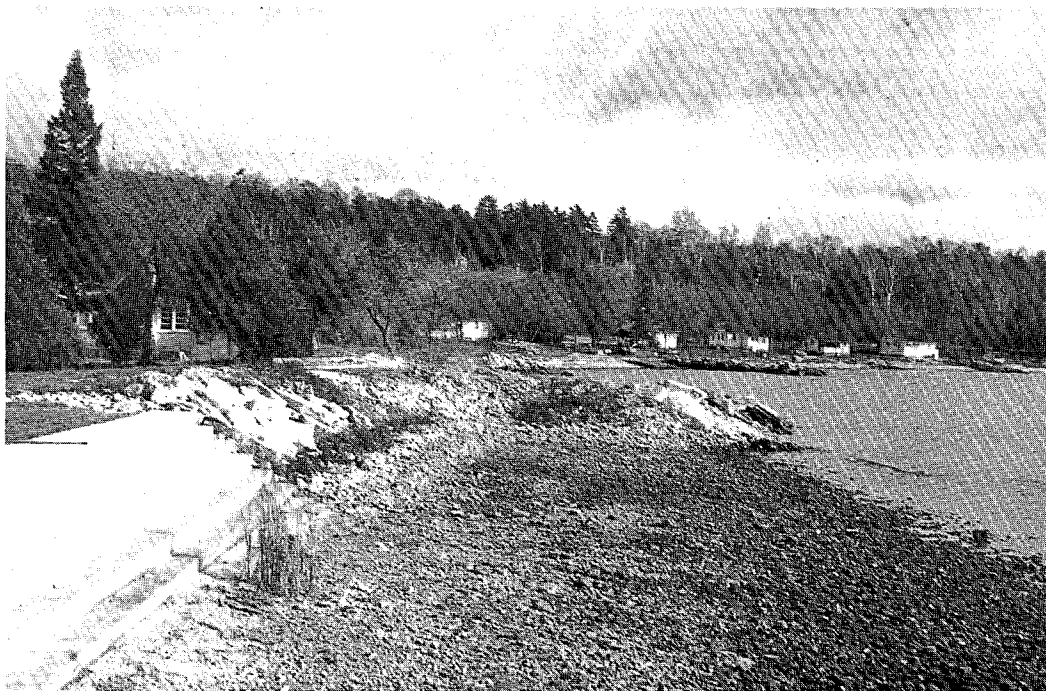
Photograph 7. Illustrates residential use of Green Bay Shoreline in the Little Harbor Area several miles north of Sturgeon Bay, Door County, Wisconsin. Gravel beach, nonerodible.

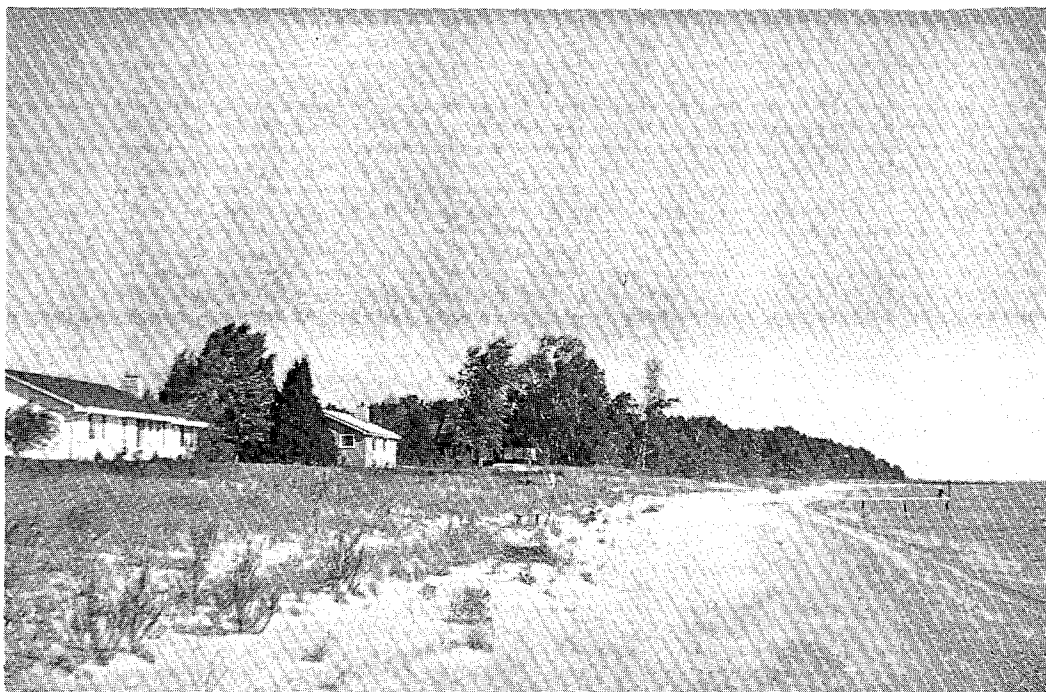
Photograph 8. Illustrates low density residential development along the Lake Michigan Shoreline, Door County, several miles south of the Sturgeon Bay canal mouth. (Sand, gravel beach, noncritical erosion.)

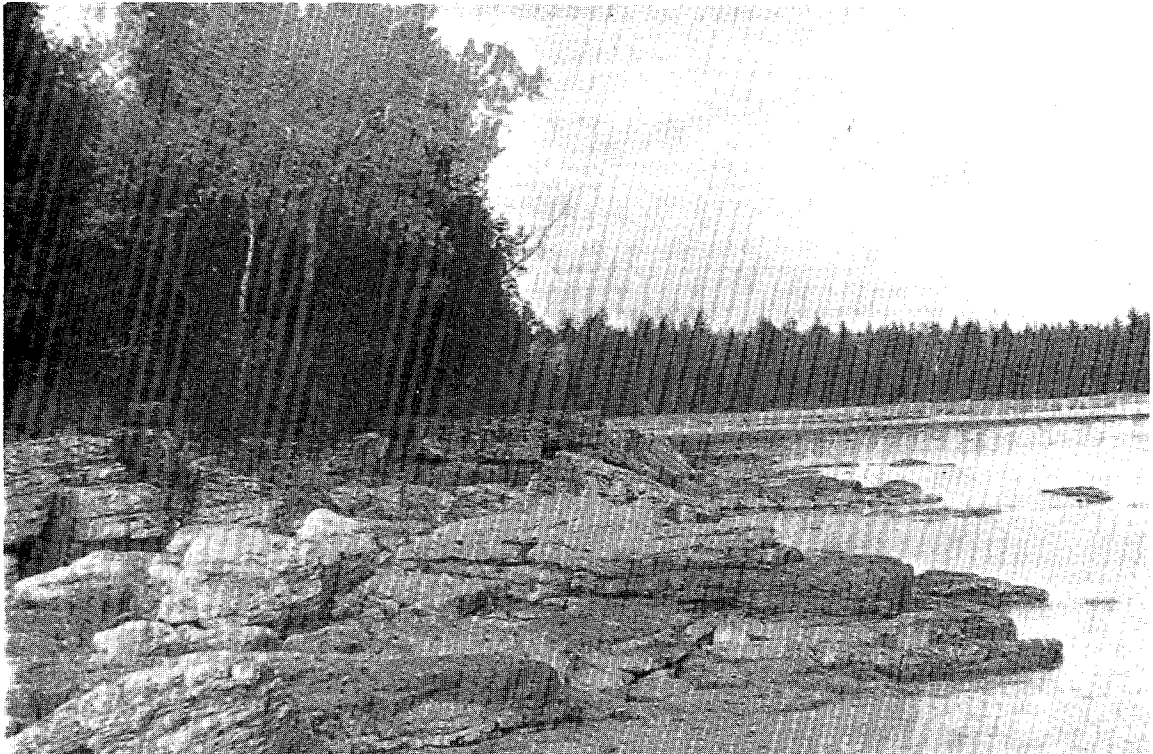
Photograph 9. Rock ledge shoreline characteristic of Door County on Lake Michigan, near Gravel Island National Wildlife Refuge.

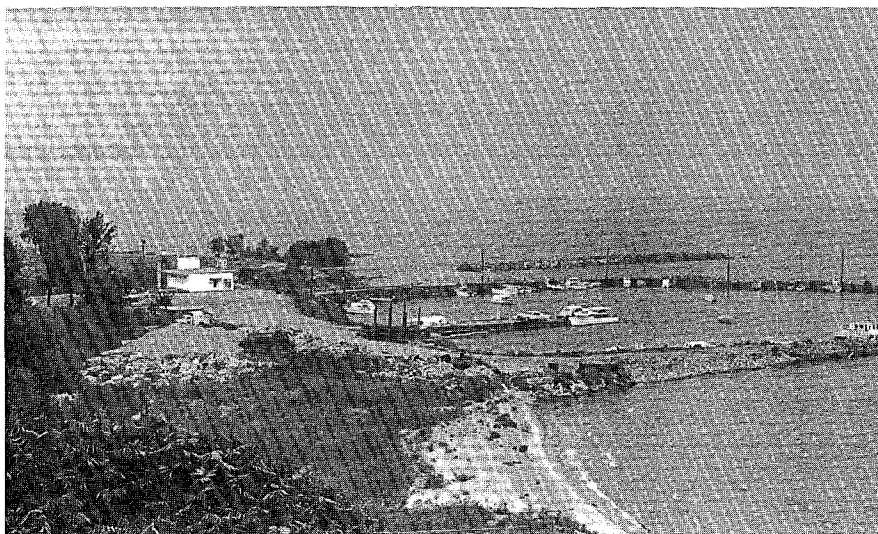
Photograph 10. View of the South Milwaukee Yacht Club with a groin in the background. Since this picture was taken a large recreational beach has accreted north of this groin.

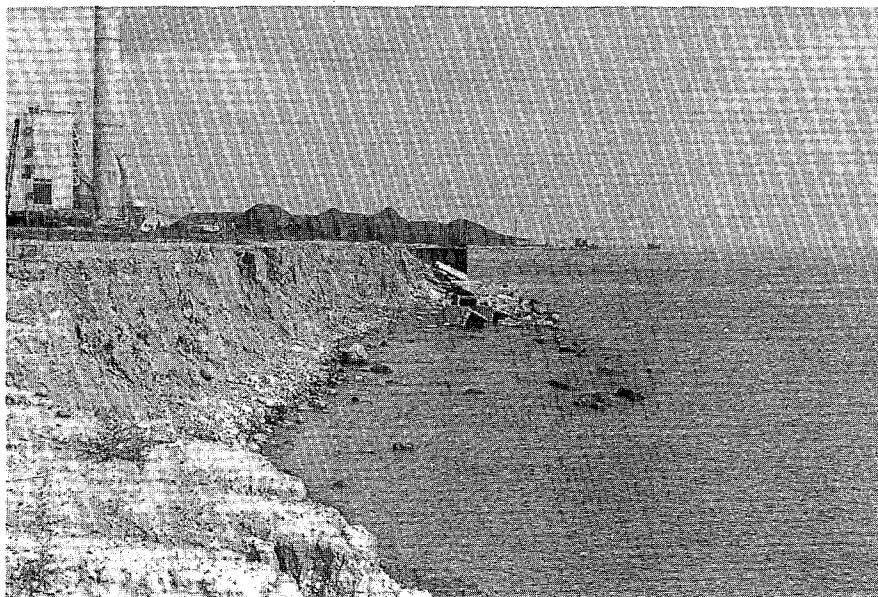
Photograph 11. Critical bluff erosion near the Milwaukee-Racine County line. Oak Creek Power Generating Station is shown in the background.

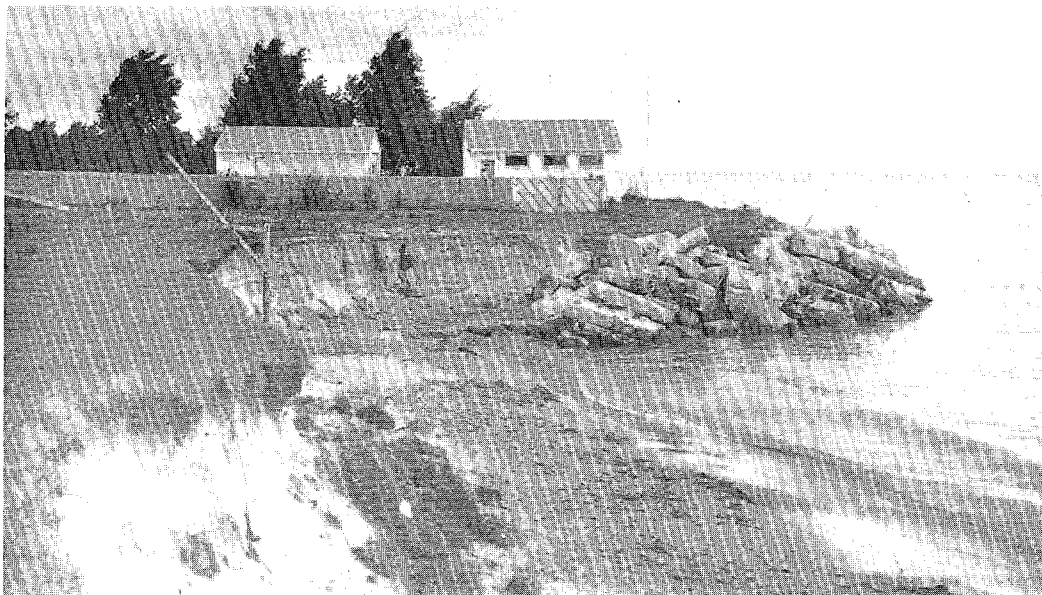
Photograph 12. Severe low bank erosion of residential shoreline two miles south of South Kenosha, Wisconsin. Broken concrete has been placed as riprap to protect residential structures from erosion damages.

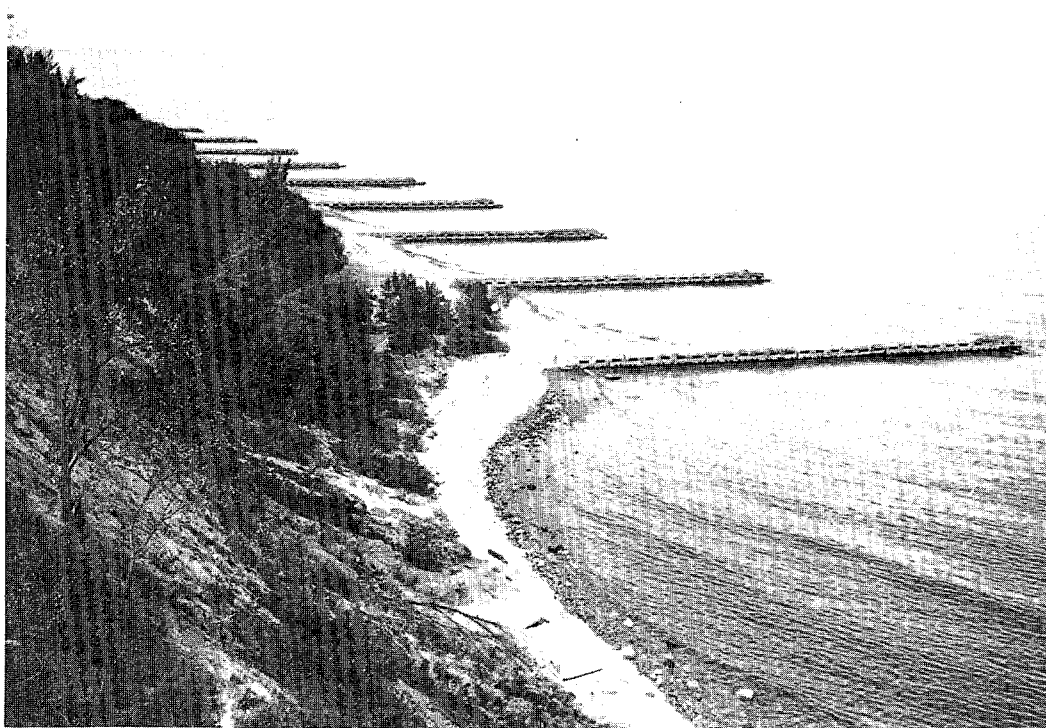
Photograph 13. Groins constructed to protect shoreline at Sheridan Park, Cudahy, Wisconsin. Sand beach accreting on the northern side of the groins due to southward littoral drift.

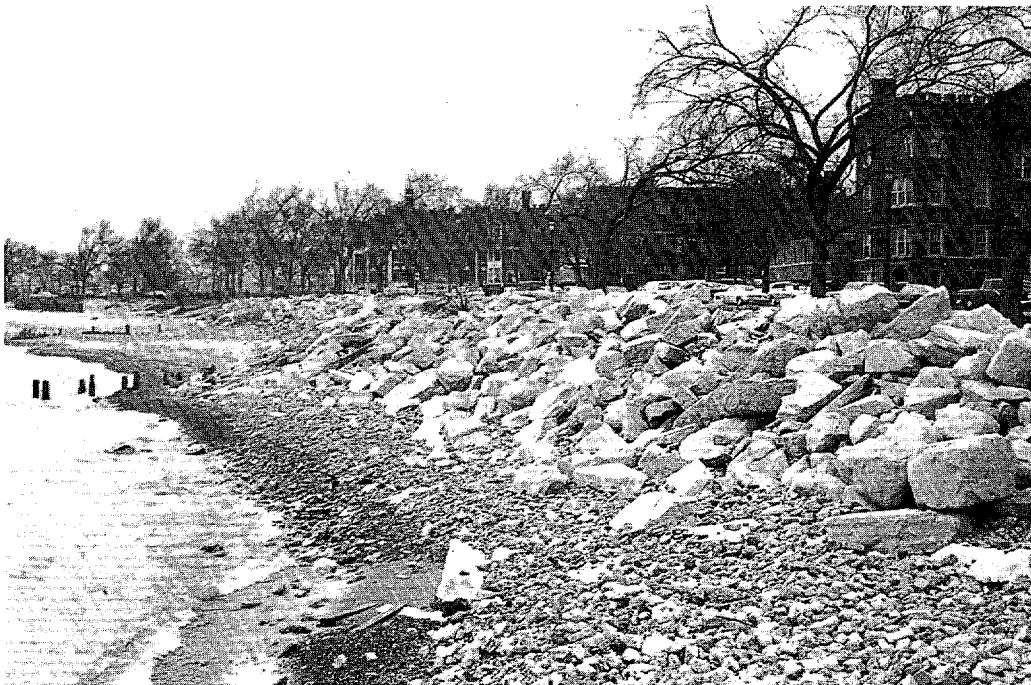
Photograph 14. An example of the use of loose rock riprap shoreline protection, 650 feet long, on Evanston, Illinois, park shoreline.

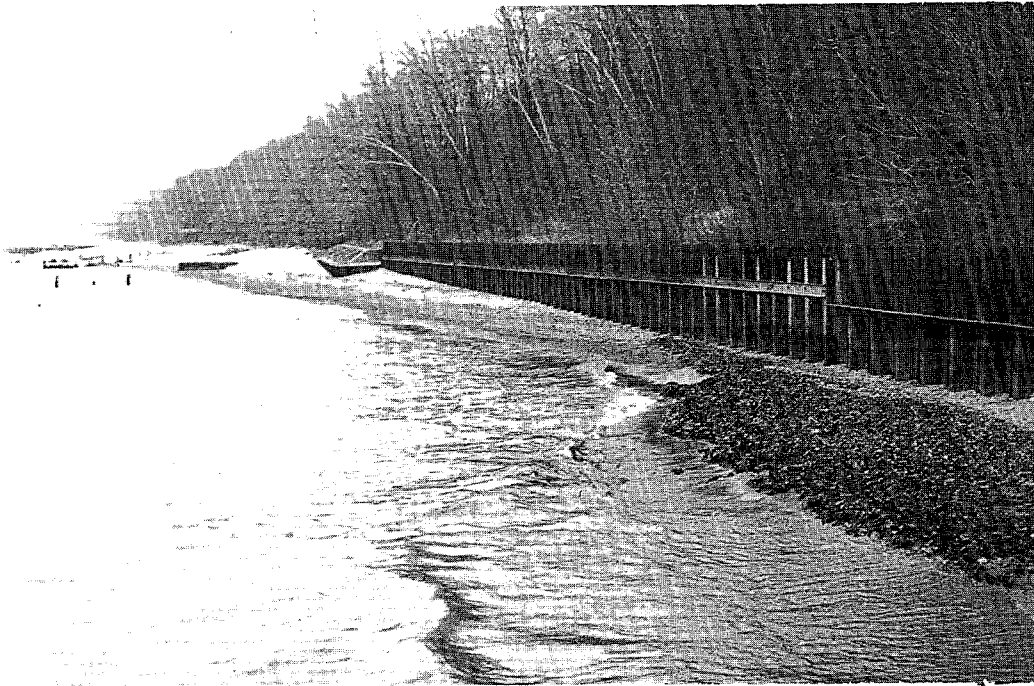
Photograph 15. Steel pile bulkhead, constructed at Glencoe, Illinois. Erosion of beach up to face of bulkhead can be attributed to groin located a few feet north of the area in this photograph. A beach is located on north side of groin. This beach is four feet higher and extends 80 feet lakeward of the beach along this bulkhead.

Wilmette Harbor to the Illinois-Indiana State line - The placing of dumped riprap and the construction of bulkheads are the best methods of protection along this reach of shore.

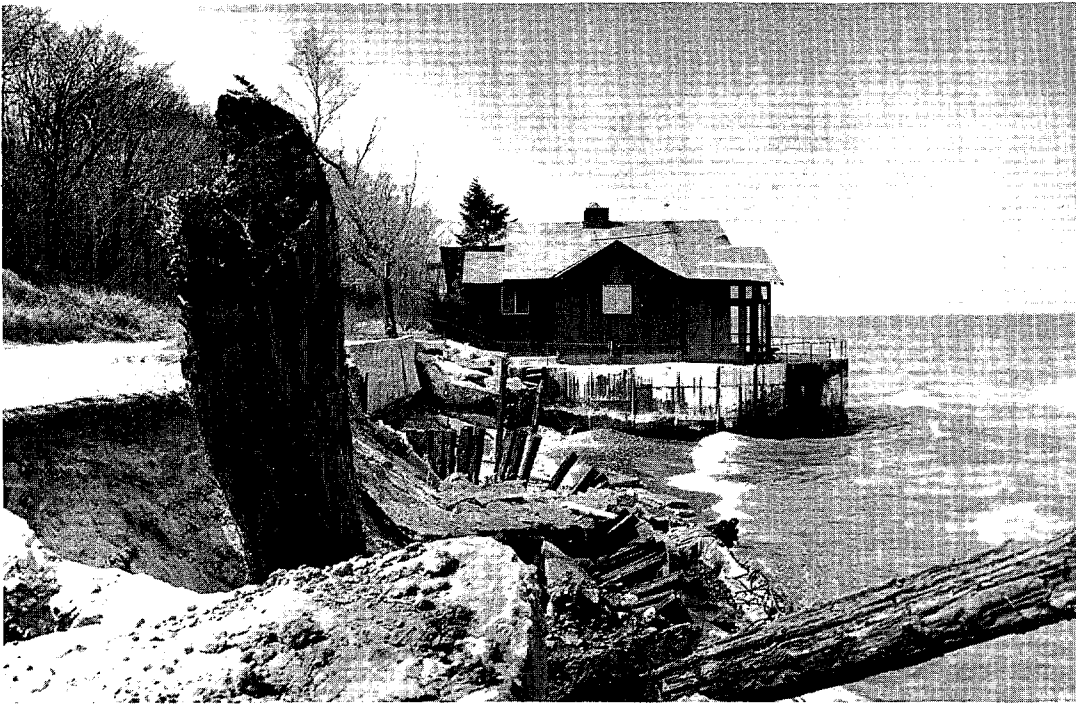
Photograph 16. The waters of Lake Michigan relentlessly wear away the shoreline surrounding a home overlooking a beach at Beverly Shores in the Indiana Dunes.

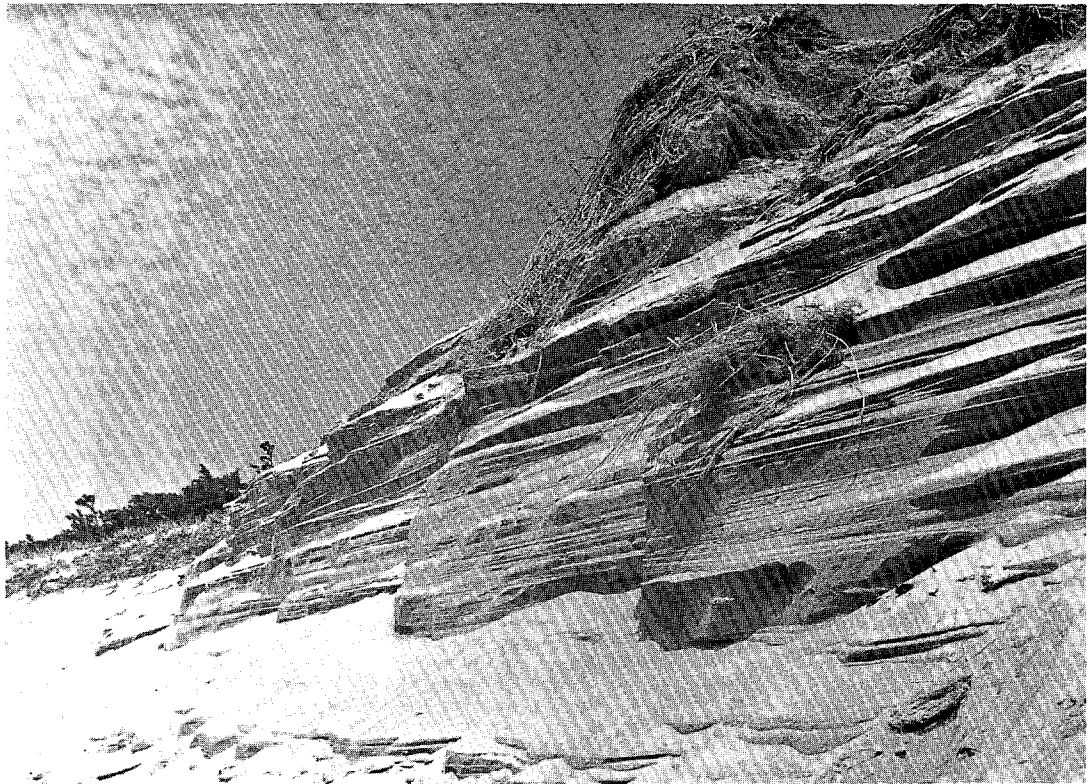
Photograph 22. Shoreline erosion in the vicinity of Little Sable Point, Oceana County, Michigan.

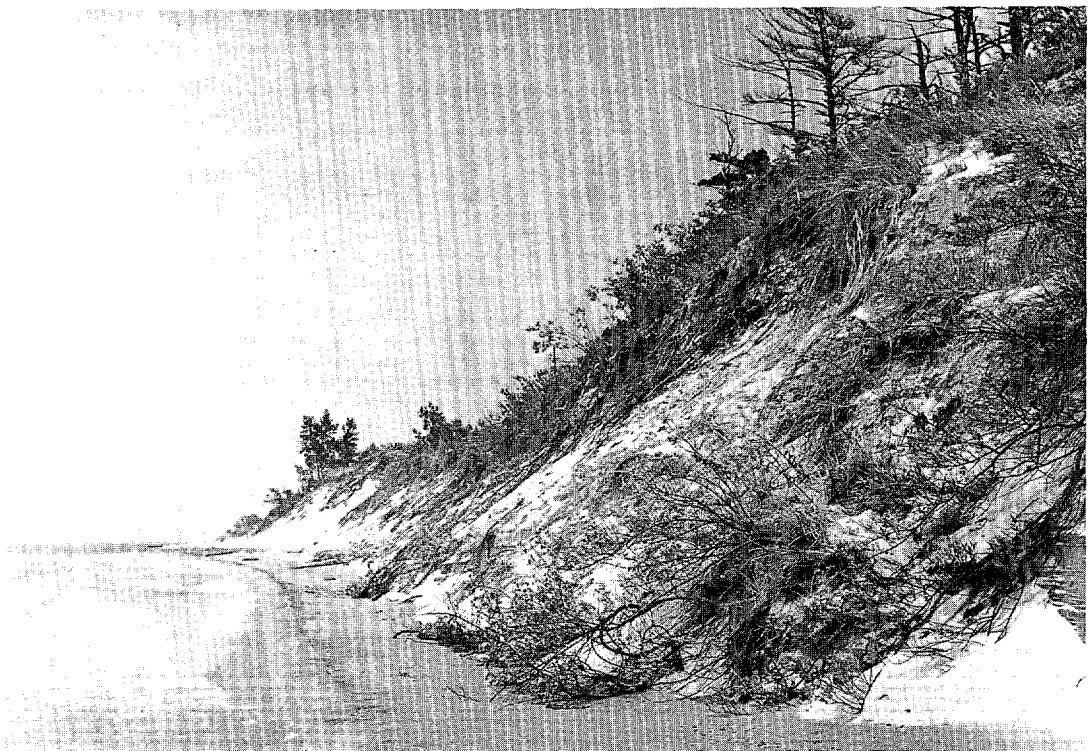
Photograph 23. High-sand bluffs fronted by narrow sand beaches in the vicinity of Little Sable Point.

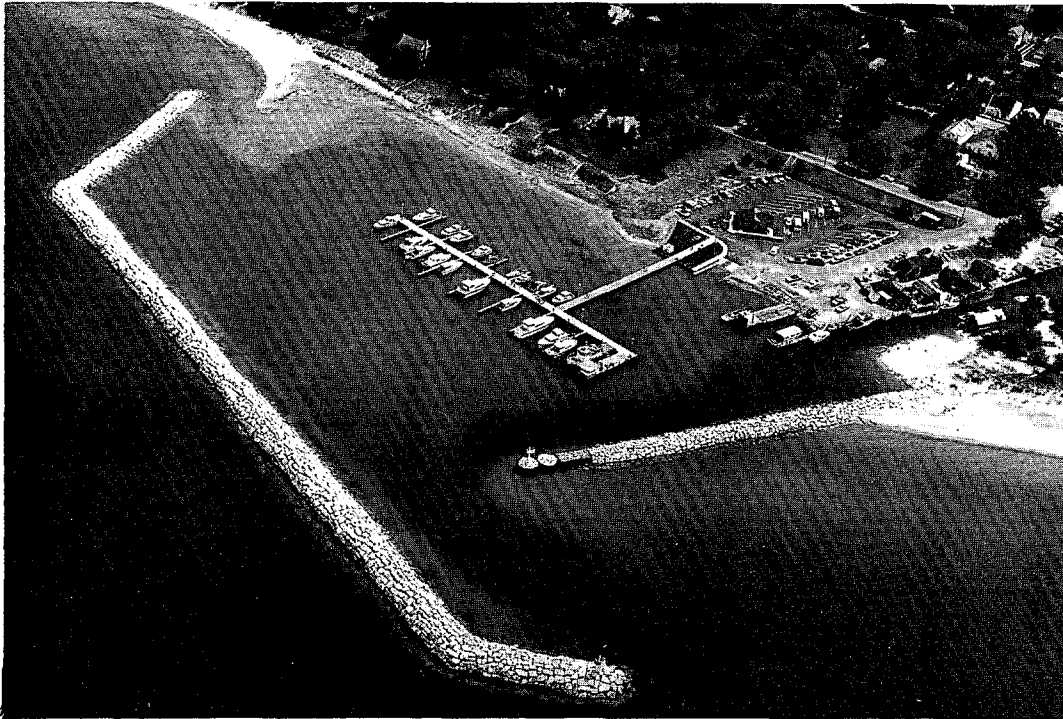
Photograph 24. A harbor of refuge located at Leland, Michigan. This harbor is designed mainly to be a place of refuge for small craft during storms.

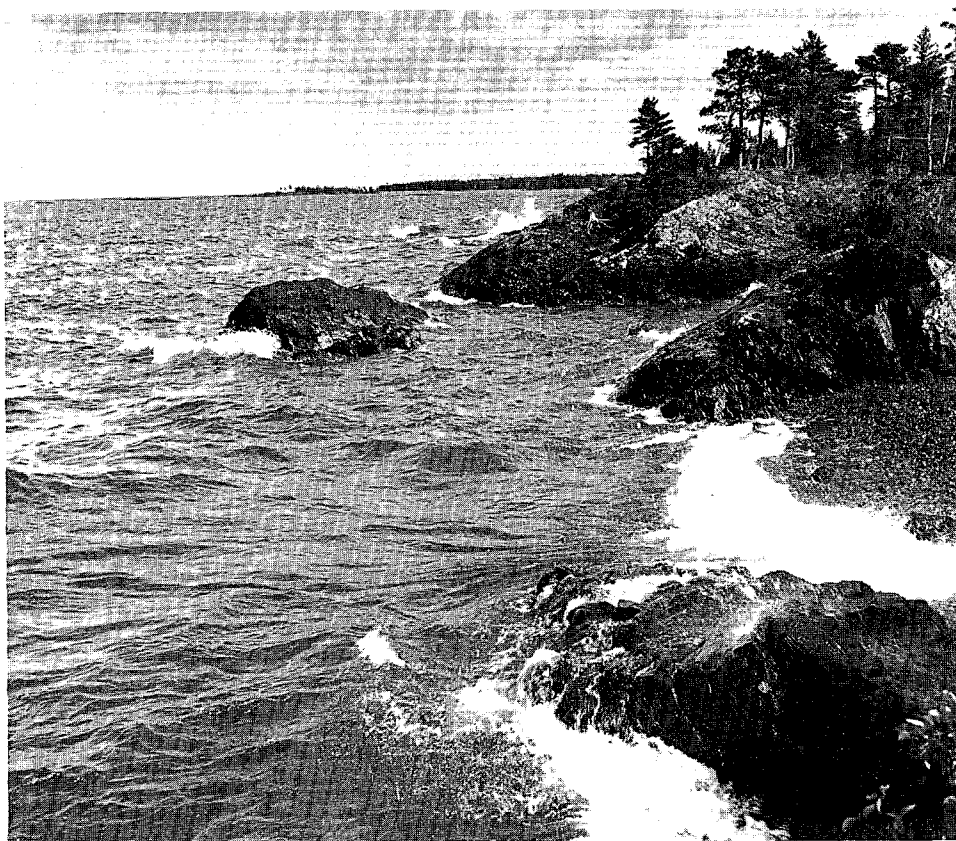
(Michigan Department of Natural Resources)
Photograph 28. Non-erodible-low bluff shoreline typical of the Lake Superior Shoreline in Michigan.

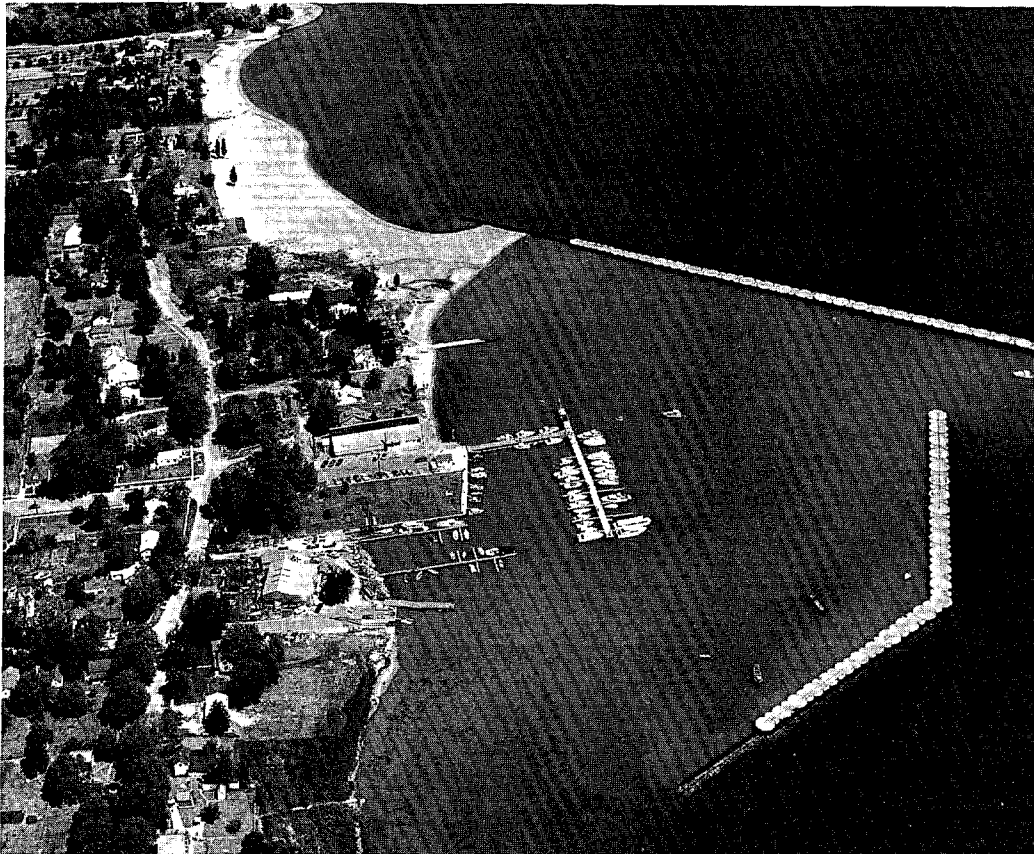
Photograph 34. Recreational Boat Harbor at Port Sanilac, Michigan.

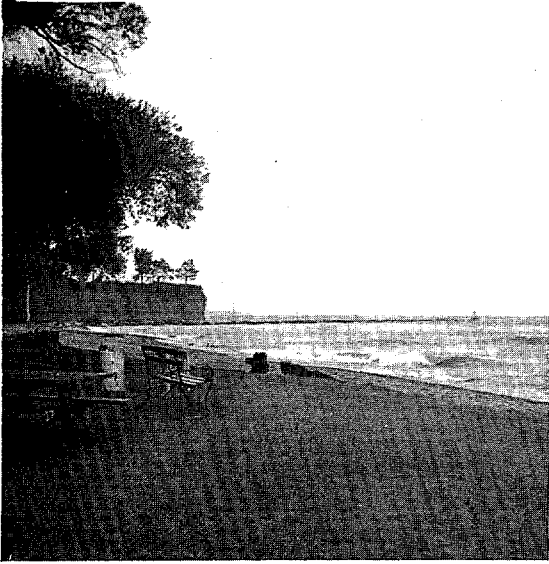
Photograph 37. Picnic area, bathing beach, and entrance jetty to the small boat harbor at Rocky River, Cuyahoga County, Ohio.

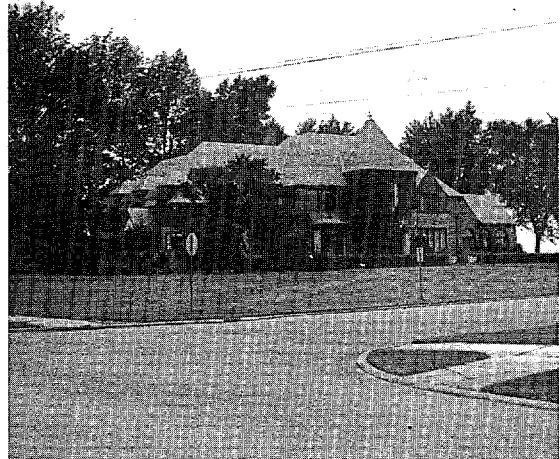
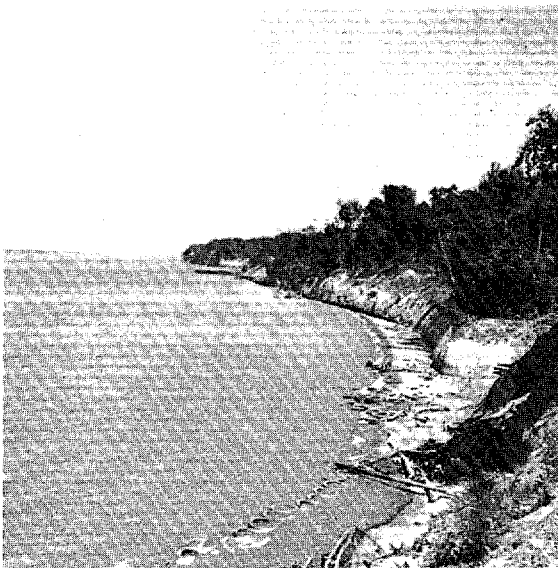
Photograph 39. Erosion of glacial till bluffs in the vicinity of Perry Township Park, Lake County, Ohio.

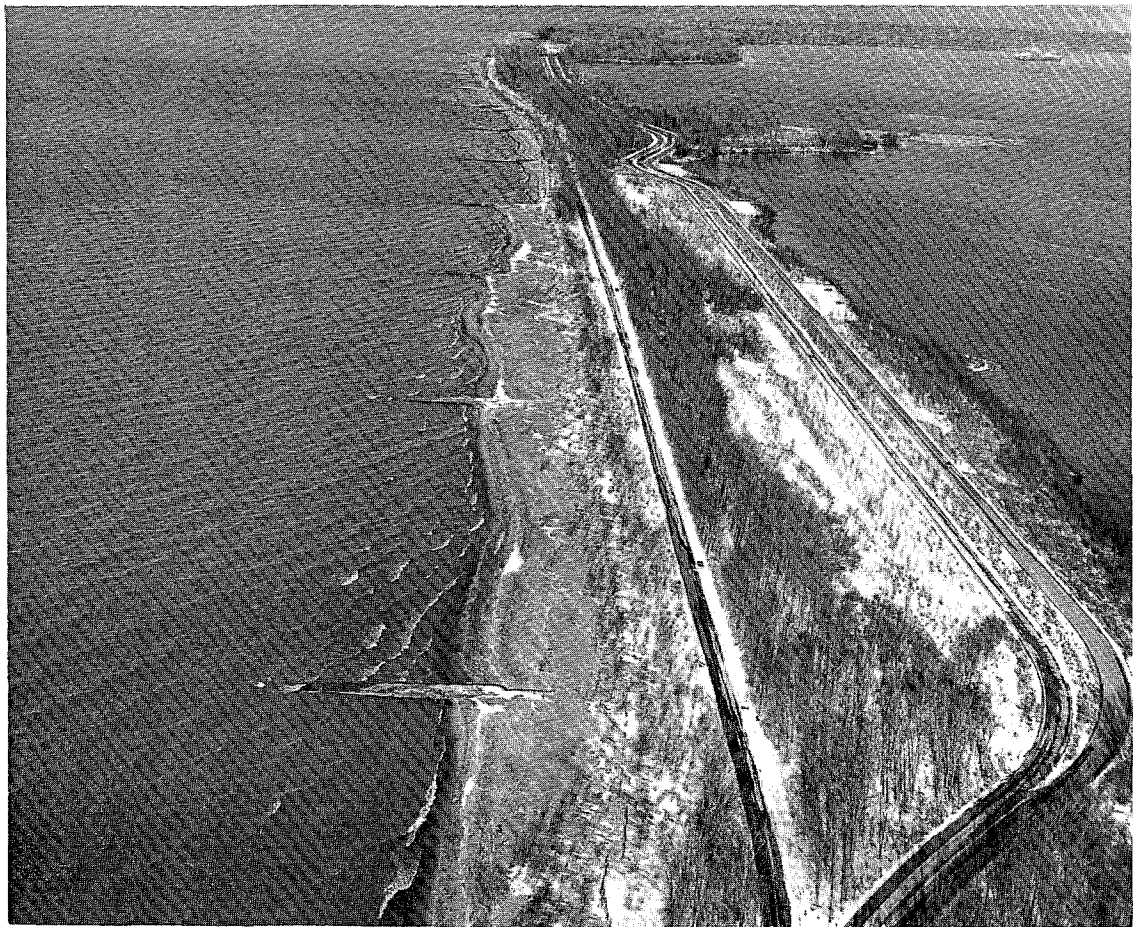
Photograph 40. Cooperative beach erosion project at Presque Isle Peninsula, Erie, Pennsylvania.

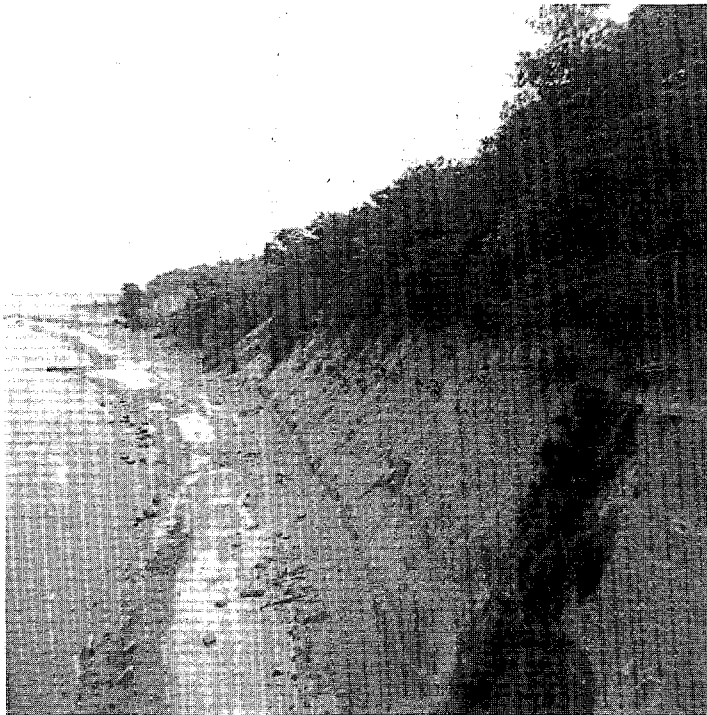
Photograph 41. Shale bluff and narrow beach about eight miles west of Buffalo, New York. This is typical of shoreline characteristics in Chautauqua and Erie Counties, New York.

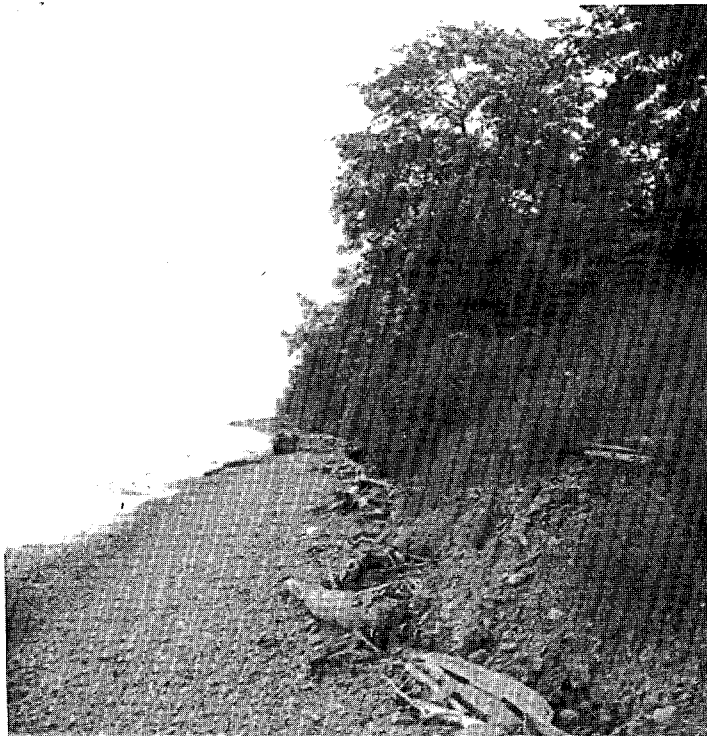
Photograph 42. Narrow beach and glacial till bluff west of Olcott Harbor, New York.

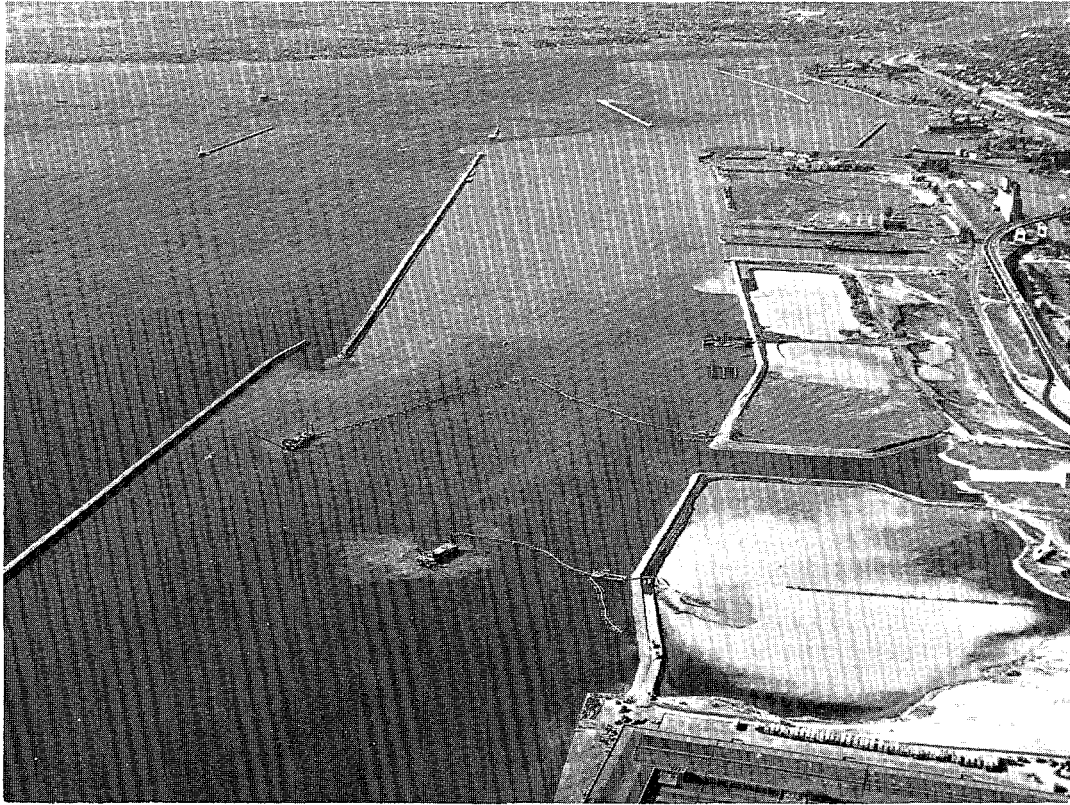
Photograph 43. Aerial view of the Buffalo outer harbor. Hydraulic dredges are deepening the Federal Project areas and depositing dredged materials behind retaining dikes. The new land will be used by the Niagara Frontier Port Authority for additional port terminal and industrial development.

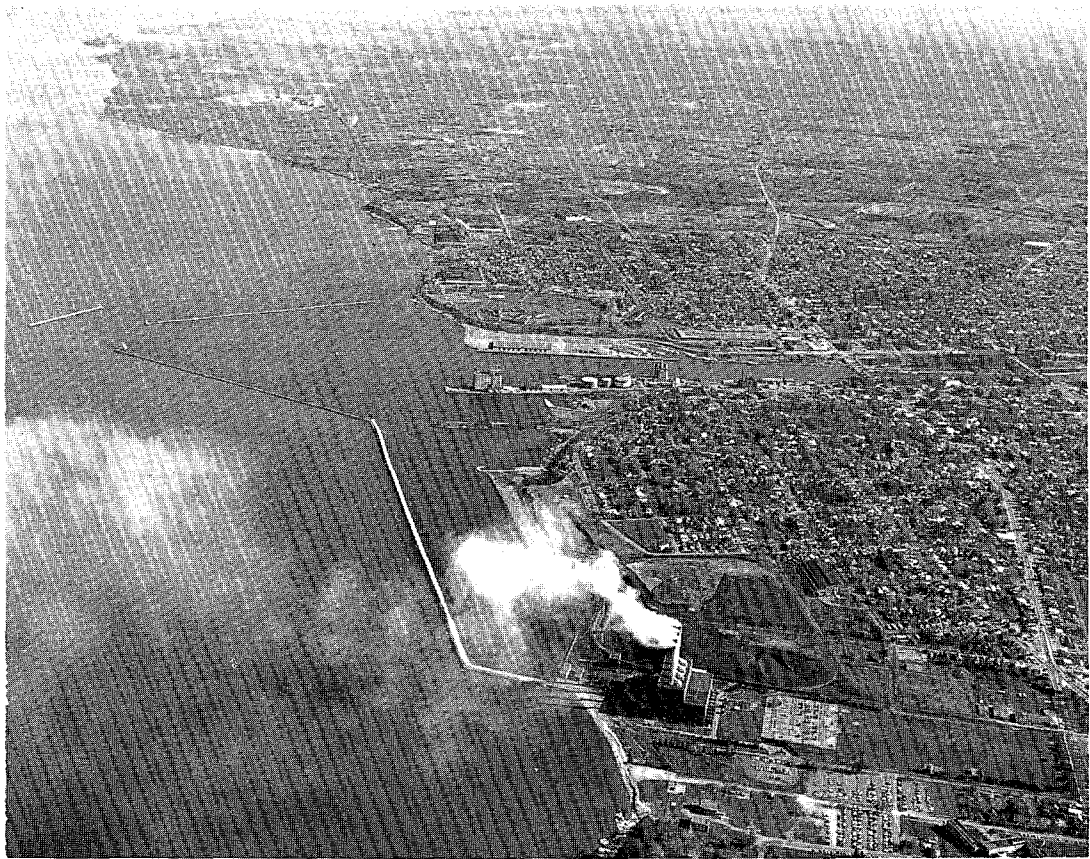
Photograph 45. The shoreline of Lake Ontario at Oswego Harbor, New York.

During an inspection of the shore made in 1966, it was found that about 0.8 mile of shore in Wayne County was protected, generally by seawalls or revetment; 0.4 mile was protected in Cayuga County; and 2.5 miles were protected in Oswego County. This included 1.4 miles behind the breakwaters at Oswego Harbor.

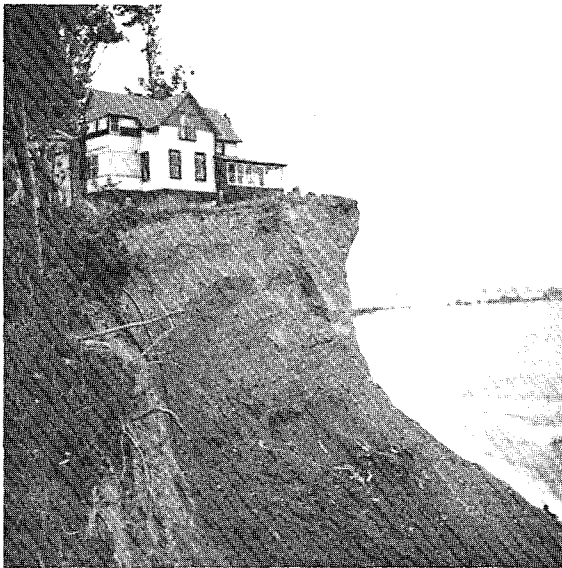
Photograph 46. Eroding high bluff just east of Great Sodus Bay. Typical of high bluffs for several miles to the east.

General information on rates of erosion throughout this three-county area is not available. Studies made at Fair Haven Beach State Park and Selkirk Shores State Park showed that at Fair Haven the average rate of erosion of the high bluff had been four feet per year between 1938 and 1952. The lower, 10-foot high bluff had eroded at a rate of 10 feet per year. At Selkirk Shores State Park, 40 feet of the bluff were lost following failure of a concrete crib seawall in 1952.
